## Diagnostic X-ray facilities as per quality control performances in Tanzania

Yesaya Y. Sungita,<sup>1</sup> Simon S.L. Mdoe,<sup>1</sup> and Peter Msaki<sup>2</sup>

*Tanzania Atomic Energy Commission,<sup>1</sup> P.O. Box 743, Arusha, Tanzania; Physics Department,<sup>2</sup> University of Dar Es Salaam, P.O. Box 35063, Dar Es Salaam, Tanzania*  
ysungita@hotmail.com

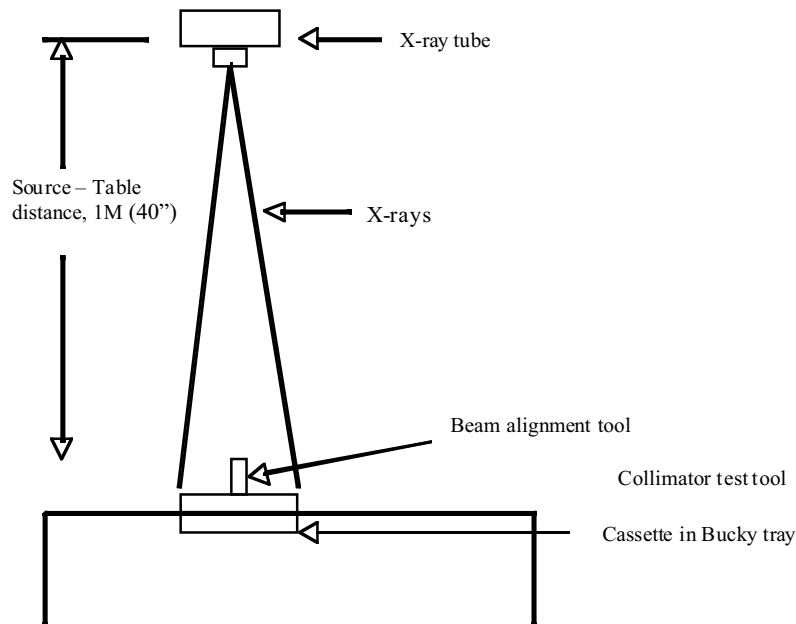
Fig. 1. Placement of collimation and beam alignment test tools for proper exposure
